DEVELOPMENT OF VEHICLES WITH A DISTINCTIVE MARK APPLIED TO THE POLICE ON THE BASIS OF PERCEPTUALITY CONSIDERATIONS FROM THE 1960'S TO THE PRESENT

BEREK Lajos; RUSZ Dániel

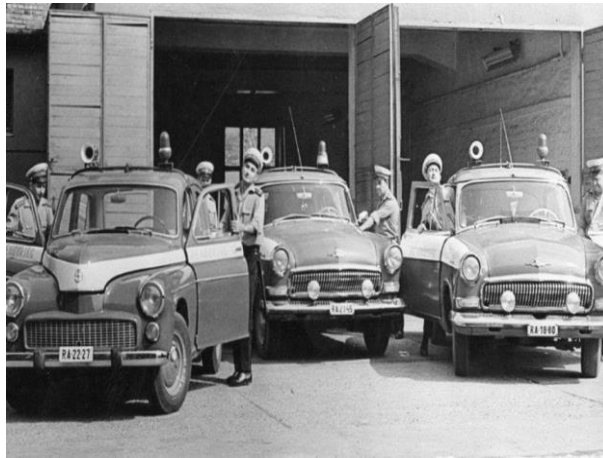
Figure 1. Warsaw and Volga type Police vehicles [3]

From the age and the previous period, it can be said in general that very minimalistic approaches were characteristic of Police vehicles in the use of distinctive light and acoustic signals. For a long time, the vehicle was mounted with a distinctive light (rotating mirror), typically a Polish-made Elektra LB-2 blinker with a 35 Watt bulb. Alongside the light signal, there is an electromechanical sounder (siren). However, the combination was not really a lucky construction because in many cases the 360⁰ degree visibility of the flash could not be realized as the speaker prevented its perception. The appearance of the cars was not considered, the basic color of the cars was essentially dark, the dark blue polishing was offset by a thin white bar on the side of the vehicles where was the Police label. The vehicles shown

in Figure 1 show the signs that were on the police cars. In the picture, there is a positive fact, two of the three cars fitted with a front fog light, which is a feature of visibility [2].

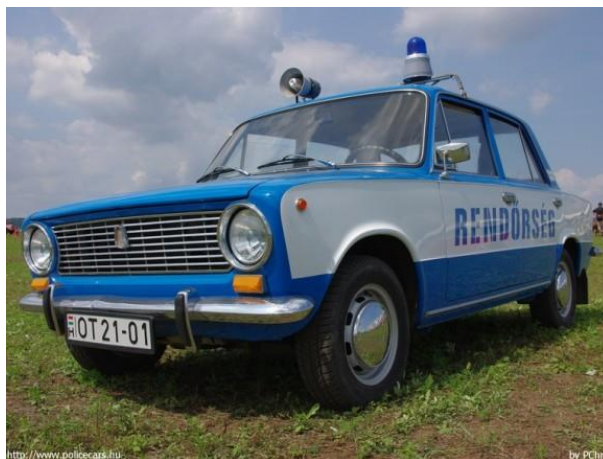
Figure 2. Vaz-2101 type Police vehicle [4]

In the 1970's, the vehicles were replaced, the VAZ-2101 police vehicles appeared, their common name was „Zsiguli” (Figure 2). There was not much difference in the perception of the cars, the white lining on the dark blue primer and the distinctive sign of a tone and light mark remained on the vehicle. With regard to visibility, the vehicle appears to have increased the size of the white sidebar on these cars, which is in any case positive, but from the viewpoint of the car, dark blue is still dominated. Considering the distinctive signs, there is no difference compared to the previous generation vehicles, it is worth mentioning that the electromechanical siren so far has been replaced by an electronic siren. The appearance of the electronic siren was an important step forward in the development of sound signals, but the Elektris H50S Speaker of the Hungarian brand and the Elektris Preston 7512 type siren amplifier, which provides the sound, is less than the performance of the electromechanical sirens. As a sign, the Polish type Elektra LB-3 type or the Hungarian type Villtesz 1.019 rotary mirror blower was used, which were not distinct from each other's construction, both types of lamps were fitted with a 35 Watt bulb.

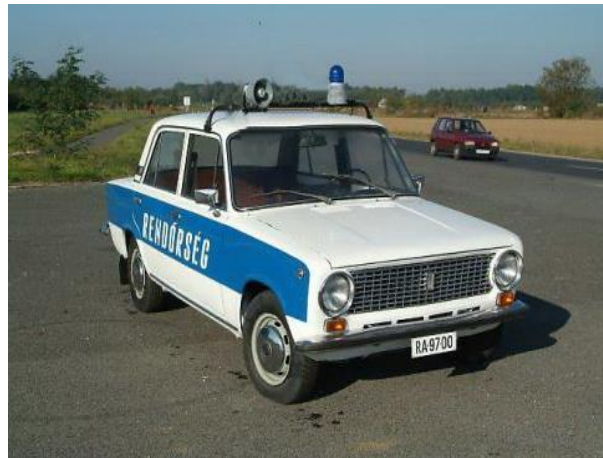
Figure 3. Vaz-2101 type Police vehicle [5]

As time progressed, the basic color of the vehicles was changed. I do not know what caused, but one thing is certain: in terms of visibility, the service cars with distinctive signs have changed. Figure 3 shows that the vehicle's refinement was reconsidered, the base color of the car changed to white and the sidebar changed to blue.

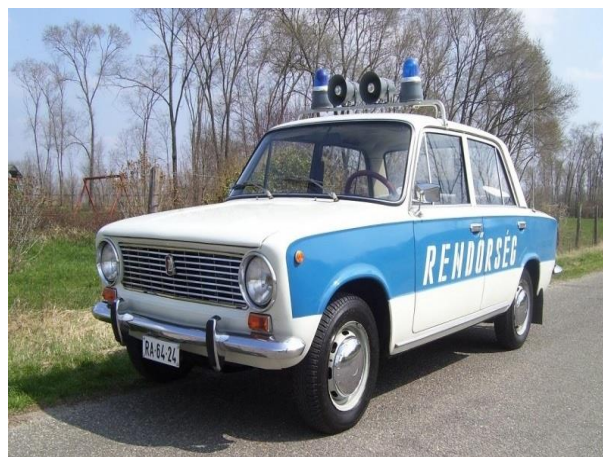
Figure 4. Vaz-2101 type Police vehicle [6]

The vehicle type and the blue paint on the white background did not change, but over time, the light and acoustic equipment was mounted on the vehicles (Figure 4). The signals were started in pairs on the car, which was also an important changes in the perception of the vehicles. The light signal was replaced by two blinkers instead of one, making the attention-enhancing effect more efficient as the duplication of the light source resulted in more light at the same time, and 360 degree visibility could be achieved, which is the most important criterion for the use of a distinctive light signal. The two speakers are located between the two light signónals, which emitted twice as much volume as a single speaker. The siren was produced by the Eriston-150 150 Watt siren amplifier manufactured by the Elektris Industrial Co-operative.

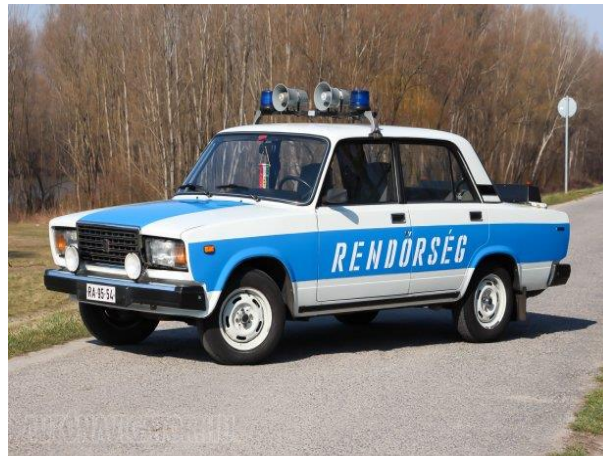
Figure 5. Vaz-2107 type Police vehicle [7]

The Vaz-2101 era approached the end and replaced this with Vaz-2107 (Figure 5). The exterior appearance (on blue on a white background) remained in the old, but unfortunately there was a problem in the field of distinctive light signals. Rotating mirrors with a 35 Watt bulb were replaced by the flashlights of the Hungarian Electric Industry Co-operative (VV

1205). The basic idea was not bad, as the consumption of these flashes was lower (5 W / s), but in the brightness these lamps did not even approach traditional rotary flashes. (Note: Blinking is a decisive parameter because the vehicle battery can be discharged within a short period of time when the light signals are used with a stationary engine.) Modernization did not affect the beep, the siren sound was still produced by the classic two speaker siren amplifiers. For the visibility, the front fog lamp mounted on the bumper on the vehicle shown on the picture, however, was not standard. Also a rarity is the light-signaling device mounted on the trunk lid. This unit was a luminous labeled "STOP, ELLENŐRZÉS".

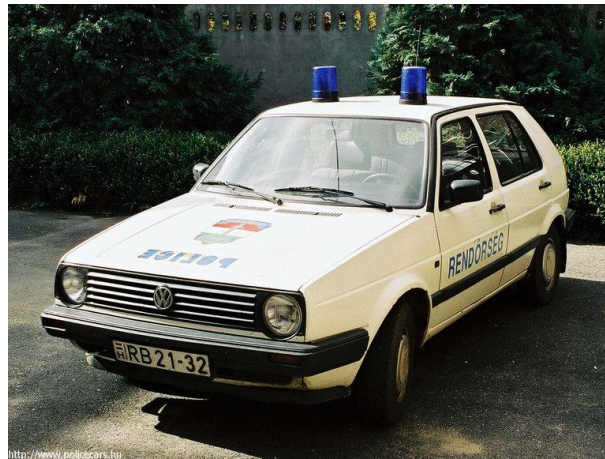
Figure 6. Volkswagen Golf II. type Police vehicle [8]

Following the change of regime, the Soviet-type patrol cars have disappeared and the German Volkswagen Golf II have appeared. New vehicles no longer had the customary custom paintwork, they were fitted with self-adhesive "Rendőrség" inscriptions (which were faded over time, their adhesives were aging). In my opinion, the design according to the economic aspects was modest. By contrast, the word "Police" label appeared on cars, which also made it clear to a foreign citizen the purpose of the vehicle. Significant changes have also occurred in the field of distinctive signs. The changes also revealed the emergence of more modern light and acoustic signalers on the Hungarian market, which were made by the German and the American. However, in the long run this resulted undermining the Hungarian manufacturers. Unfortunately, they were not able to compete with foreign suppliers (even though they would have been able to meet the technical requirements). The Golfs were fitted with a German Hella-type KL 700 rotating mirror or blinkers (one or two) in which 55 Watt halogen bulbs emitted the light. (Note: The Elektris Industrial Co-operation also produced a 55 Watt halogen flash bulb (FV 1255), but it could not be sold in large numbers.) The sound signal was also delivered by German Hella or American PSE CODE3 Inc. Also visible on the picture, there are no speakers on the top of the vehicle, the unit was placed in the vehicle's engine room, which was capable of delivering ~100 Watts of sound power.

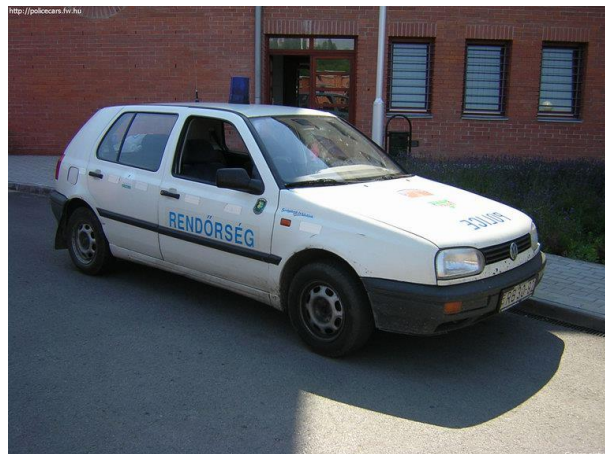
Figure 7. Volkswagen Golf III. type Police vehicle [9]

The German brand is proven. Volkswagen Golf II has been replaced by Golf III (Figure 7). There was no change in the light and sound signals, and the appearance of the vehicle did not change, too. The only, but still very important, innovation is visibility and visibility in the dark. They used to apply reflective stickers. On both sides of the vehicle and on the back, white-colored (American company (3M)) self-adhesive prisms were placed, showing the position of the patrol car in the form of a dotted line running through a car. This solution was very innovative at that time in our country.

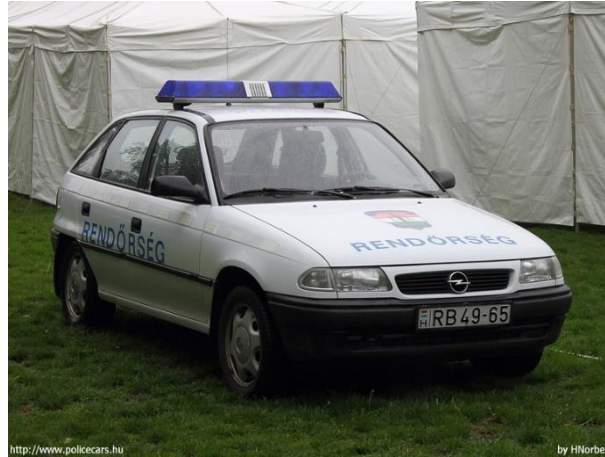
Figure 8. Opel Astra F type Police vehicle [10]

Later, Volkswagen Golfs were replaced by nearly a thousand Opel Astra F cars (Figure 8), which were manufactured in Szentgotthárd and were specially made for the Police (reinforced chassis, shock absorbers, rims, etc.). In the appearance of the vehicle, the external parts of the vehicle did not change much, the adhesive stickers in their style remained unchanged in the vehicle body. The international "Police" has, however, disappeared from the hood, although it can be explained by the fact that in the shield can still be read. On the side of the car, the self-adhesive signals with white reflective properties were still applied. As a distinctive light and acoustic signal was first installed on the Astra. It was the LP-6000 light bars produced by American PSE CODE3 Inc.. In these light shades there were 4 rotating mirror units (two or two on each side) with a 55 Watt halogen bulb and a 100 Watt speaker. Among the flash units, additional mirror lenses helped to lighten the light, thus achieving even better efficiency using the light bar. The siren amplifier was also manufactured by the American company and

its model number was 3692. This amplifier was already equipped with a microphone at the factory, so it was possible to voice the voice. (Note: older siren amplifiers also had a microphone input, but the microphone was not included in the unit.) The siren amplifier and light bar used by the Opel Astras were both a modern and epoch-making solution for the use of distinctive signals.

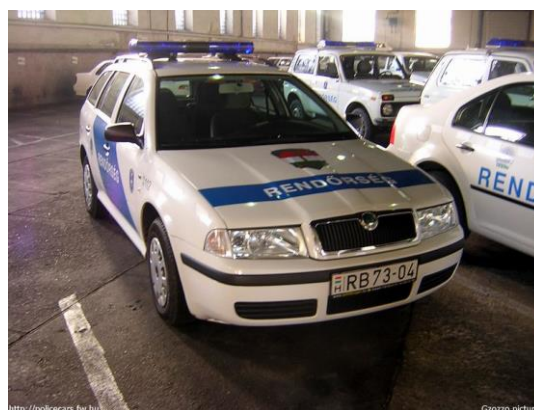
Figure 9. Skoda Octavia type Police vehicle [11]

With little irony, for the appearance of today's police cars we had to wait for two thousand years. After the Opel Astra F police cars, the Skoda Octavias appeared on Hungarian roads (Figure 9). The Czech wagon showed a new picture of the organization, and the type and appearance of the car were equally authoritative. Blue and white bands appeared on the front and side of the white base vehicles, giving a more prominent appearance to police cars. The blue color paralelogram painting on the doors has now become a trademark of Hungarian police vehicles, but because of the blue surface did not yet have retro-reflection and the visibility of the low light conditions continued to be reflected on the sides of the vehicle. Distinctive signals have also been exchanged, the procurement procedure was won by the Spanish Federal Signal Vama, thus the Federal Signal P7000 / 8000 light bar and the AS320 siren unit were added to the new police cars. The signs indicate that they were characterized by more aesthetic and modern design, but in their operating principle and performance there was no significant difference with CODE3 products.

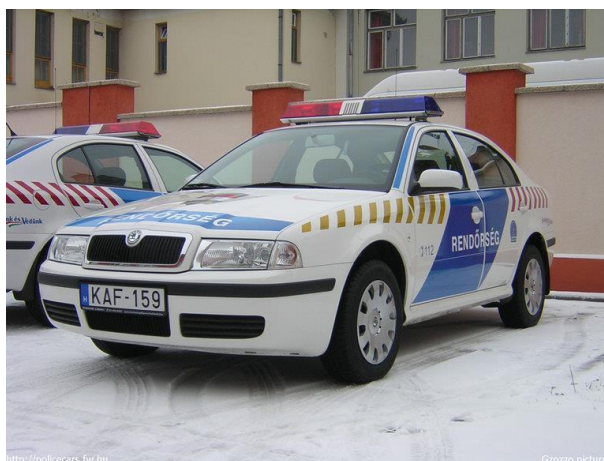
Figure 10. Skoda Octavia type Police vehicle [12]

By around 2005, the fleet was again upgraded and replaced. The Skoda remained (Figure 10), Federal Signal Vama signals were removed from the top of the cars, and the CODE3 LP-6000 light bars returned to CODE3 MicroCom-2 siren amplifiers. In the operation and technical parameters of the right red lampshade of the light bar signified a significant difference. The red lampshade has also signaled the beginning of a new era, as blue-red distinctive light signals have now been completely displaced by blue-blue signals. The use of the red light signal was justified by technical and professional considerations since the wavelength of this light is the largest in the visible range (human eye), so the red light goes to the farthest. Thanks to the conventional painting method, luckily in this case the use of more modern materials justified this decision. Instead of polishing the bodywork, the polarity of the vehicle was developed with the use of long-lasting, plastic-based, self-adhesive and reflective properties (eg Reflexlite). During this period, the final "uniform" of the patrol cars was developed, which was later recorded in the ORFK instruction. Apart from the use of a slightly lighter bar from time to time, the quality and quantity of materials and devices used in the car have changed in every direction. Visibility - beyond the red and two blue flashing lights of the light bar - were provided with blue, yellow and red reflective self-adhesives covering a large part of the bodywork, making it virtually recognizable by the vehicle (by light).

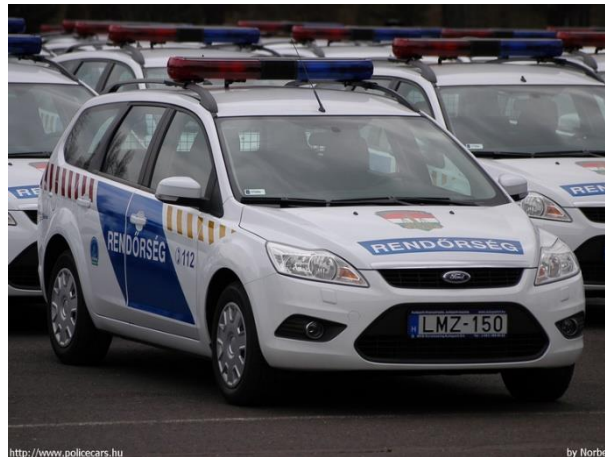
Figure 11. Ford Focus type Police vehicle [13]

Skoda was replaced by Ford Focus in 2009-2010 (Figure 11). The appearance and position of the reflective self-adhesive did not change because of the design. The distinctive mark on the first Ford Focuses was still the usual CODE3 system, but on later vehicles, the already obscured Federal Signal Vama P7000 / 8000 light bars and the AS-320 sirens have been re-released. It is not visible at first sight, but the inner structure of the light bar has become more modern, with two LEDs (one side at the edge of the light bar) of the four rotating mirrors, alternating with a LED blinker (module). The Ford Focus was the first type of car for which a (partly) LED distinguishing light was fitted. The front fog lamp has also become standard on the type.

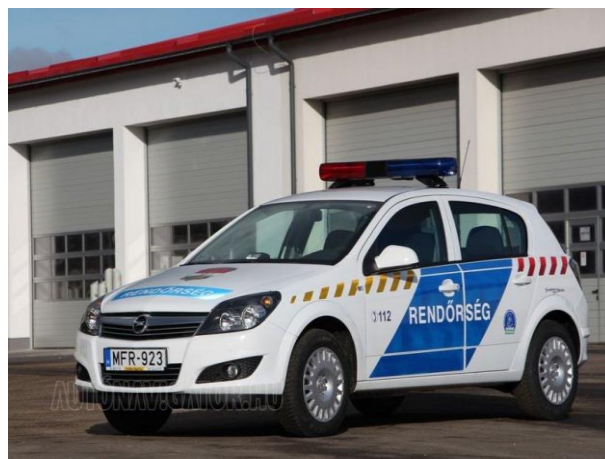
Figure 12. Opel Astra H type Police vehicle [15]

Finally, the good old Opel Astra returned in 2013 (Figure 12). The design for Astra did not change, perhaps it is worth mentioning that the base colors of the vehicles used by the Standby Police were silver (metallic gray), and these cars had a gray reflective adhesive foil. The distinctive light has been replaced, though they have stayed with the Spanish brand, this time the Federal Signal Vama Phoenix LED light bar was chosen. There are only one LED module per side in this light bar, and on the two ends of the light bar a so-called „alley light” or „work light” of a white light (halogen bulb) has been designed by the manufacturer. Behind the windshield, an additional LED is also fitted with a distinctive light signal, while the Viper S2 Solaris indoor blinker is also a member of the Federal Signal family and emits a strong blinking blue light when the light bar is operated[14].

In my opinion, the currently-used Opel Astra H types of police vehicles are appropriate to the age, modern distinctive signs and high-quality reflective foils contribute greatly to improving the safety of traffic, but I find it important to note that these devices are not guaranteed against an accident, therefore it is indispensable for everyone involved in responsible behavior. Finally, there is always room for improvement. I trust that the technical standard and approach that characterizes this area is not stop at the current level, and there is a constant need for innovative tools and solutions.
